**Subject: Oil Spill Emergency Response Summary Report, Revision 0
Spring Brook Marina Site – E22508
Seneca, LaSalle County, Illinois
EPA START Contract No.: 68-HE-0519-D0005
Task Order-Task Order Line Item No.: F0071- 0001DE106
Document Tracking No.: 1346**

OIL SPILL EMERGENCY RESPONSE SUMMARY REPORT

**SPRING BROOK MARINA SITE – E22508
SENECA, LASALLE COUNTY, ILLINOIS**

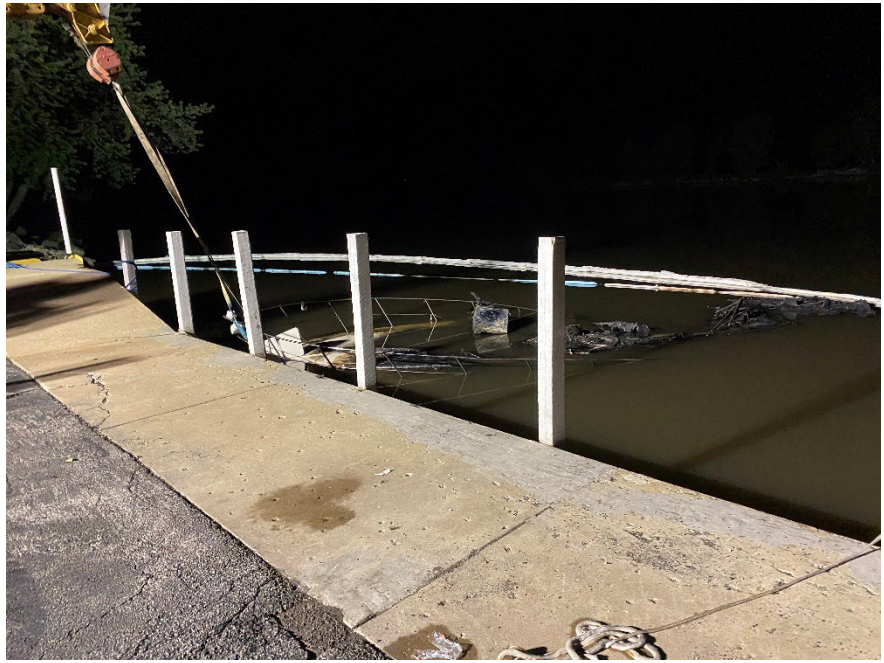
Photograph No. 1

At 2330 hours, EPA, START, and the LaSalle County Emergency Management Authority representative conducted a reconnaissance of the Site. During this reconnaissance, the sunken vessel encircled with oil booms deployed by the PRP was observed. Debris and a sheen appeared to be flowing from the sunken vessel and was contained within the booms (Appendix B; Appendix C). The sheen was cloudy and exhibited faint iridescence, indicating the likely presence of petroleum.

Description: View of the sunken vessel in the Illinois River. Oil booms deployed by the potentially responsible party (PRP), Spring Brook Marina, as well as a crane holding on to the bow of the vessel are visible.

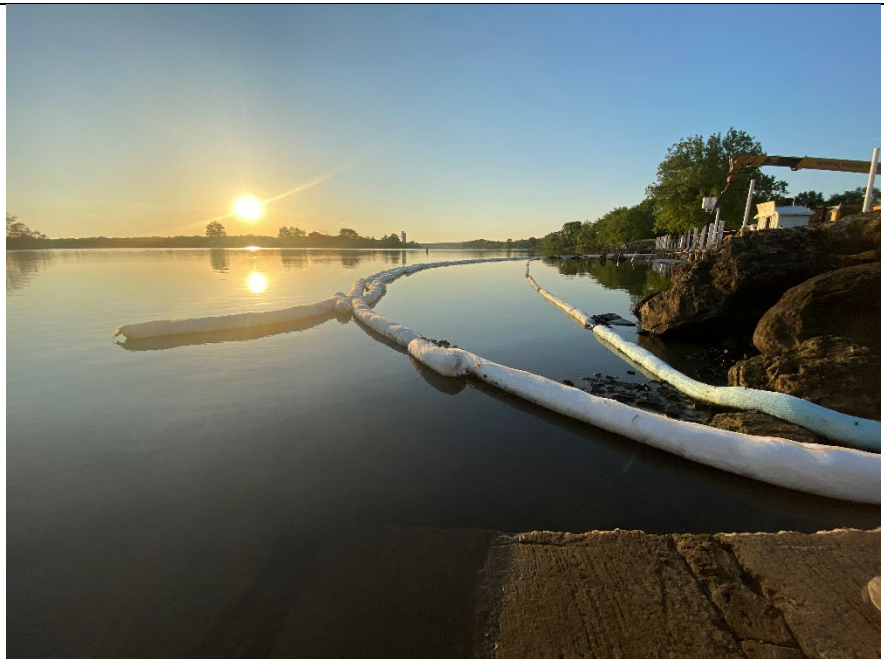
Photograph No. 2

Description: View of the oil booms and captured debris.

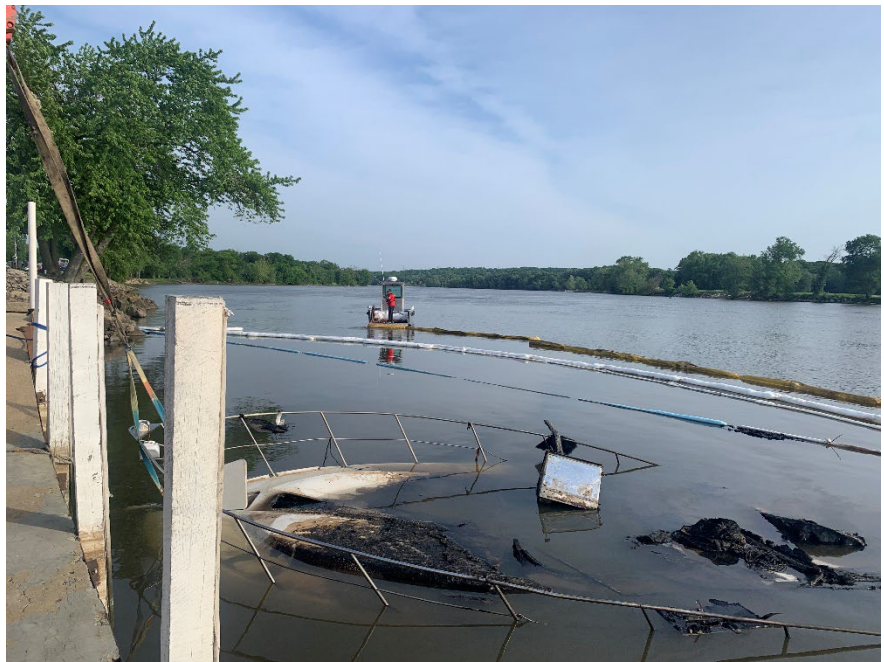
Photograph No. 3

Description: View of the PRP's contractor, Tow Boat US, installing a hard boom along the perimeter of the oil booms.

At 0635 hours, the PRP towing contractor, Tow Boat US, arrived at the Site. The towing contractor, PRP, Seneca Fire Department, and LaSalle County Emergency Management Authority determined that the best method to recover the sunken vessel would be to install a hard boom at the perimeter of the sunken vessel oil booms, use divers to position and inflate lift bags beneath the sunken vessel, raise the vessel off the riverbed, and then tow the raised vessel into a bay where a boat hoist could recover it. At 0655 hours, Tow Boat US set a hard boom at the perimeter of the sunken vessel oil booms.

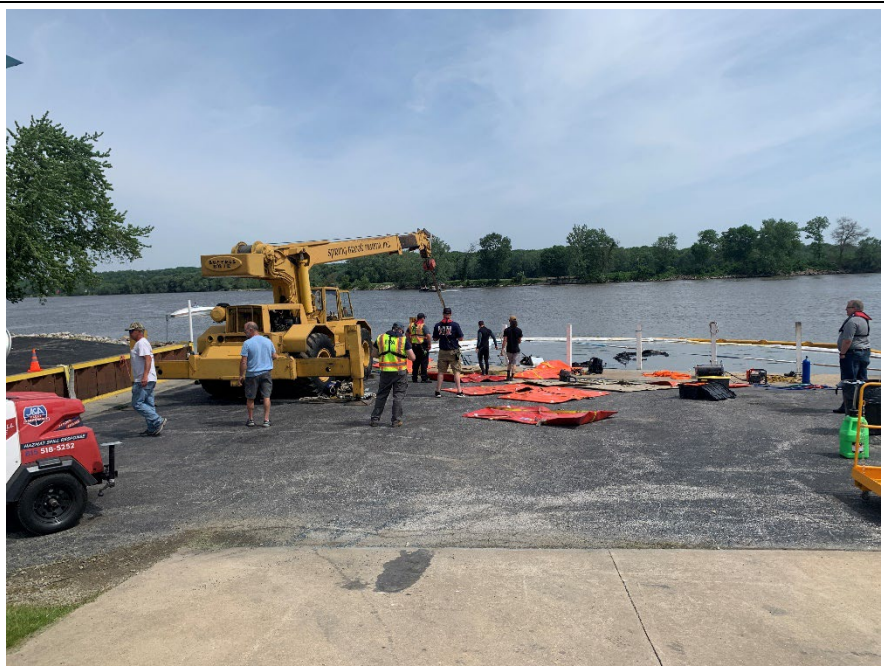
Photograph No. 5

Description: View of the deflated lift bags ready for use as the dive team concludes their safety dive.

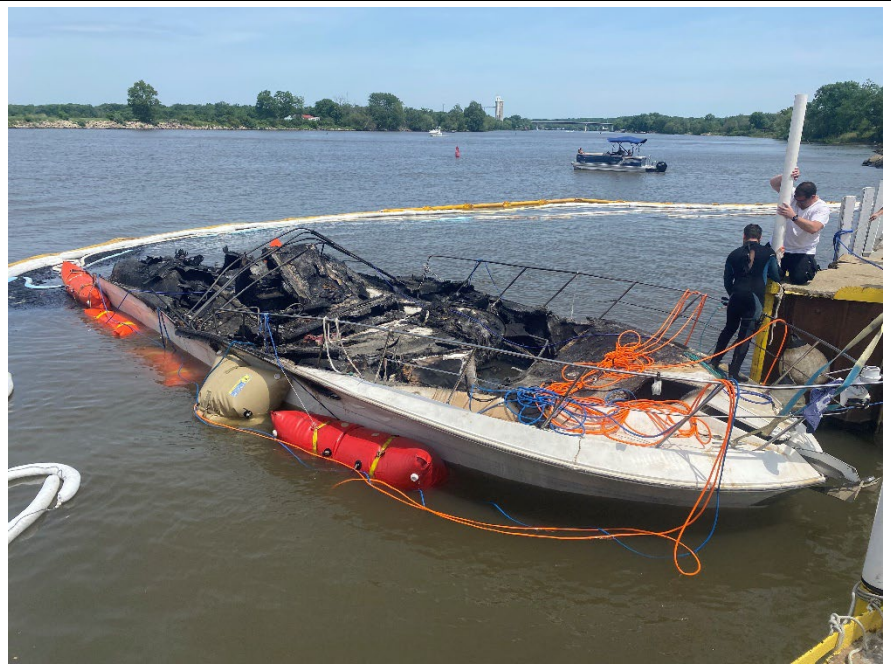
Photograph No. 6

Description: View of the vessel raised from the riverbed using inflated lift bags.

At 1334 hours, the dive team successfully installed and inflated enough lift bags to raise the sunken vessel off of the riverbed. The PRP then used a crane connected to the bow of the vessel to guide the vessel into a bay where a boat hoist was stationed. At 1400 hours, the PRP used the boat hoist to slowly lift the vessel from the bay. The crane and boat hoist emitted exhaust with a strong combusted diesel-like odor into the surrounding air. The vessel was lifted slowly to keep it intact and to minimize additional releases of debris into the Illinois River. As the vessel was lifted, pieces of burned debris occasionally broke off and a cloudy, faintly iridescent sheen was released from the pieces. The oil boom and hard boom perimeter successfully contained all burn debris and most of the sheen that was released from the burn debris.

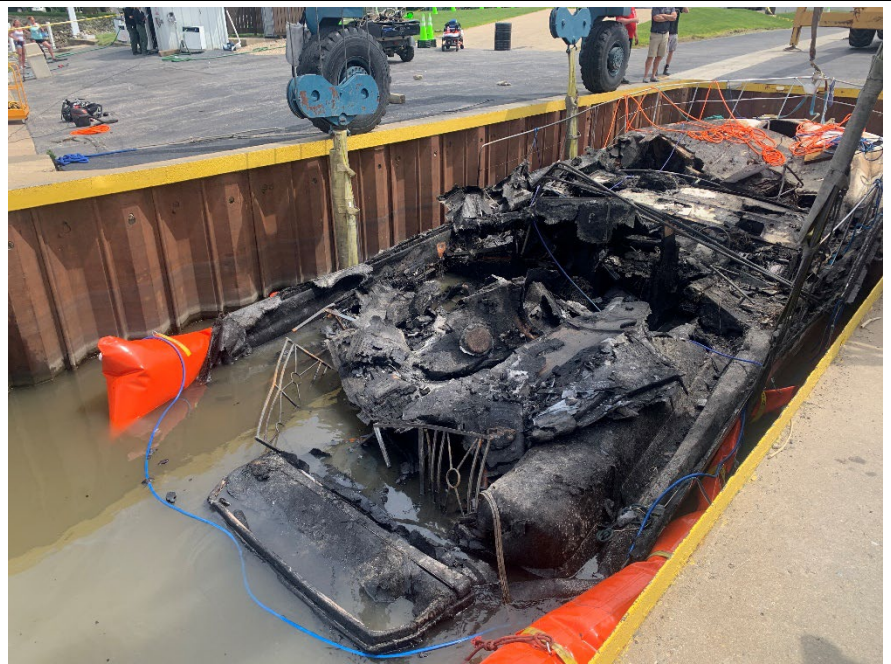
Photograph No. 7

Description: View of the vessel attached to the hoist in the bay in preparation for removal.

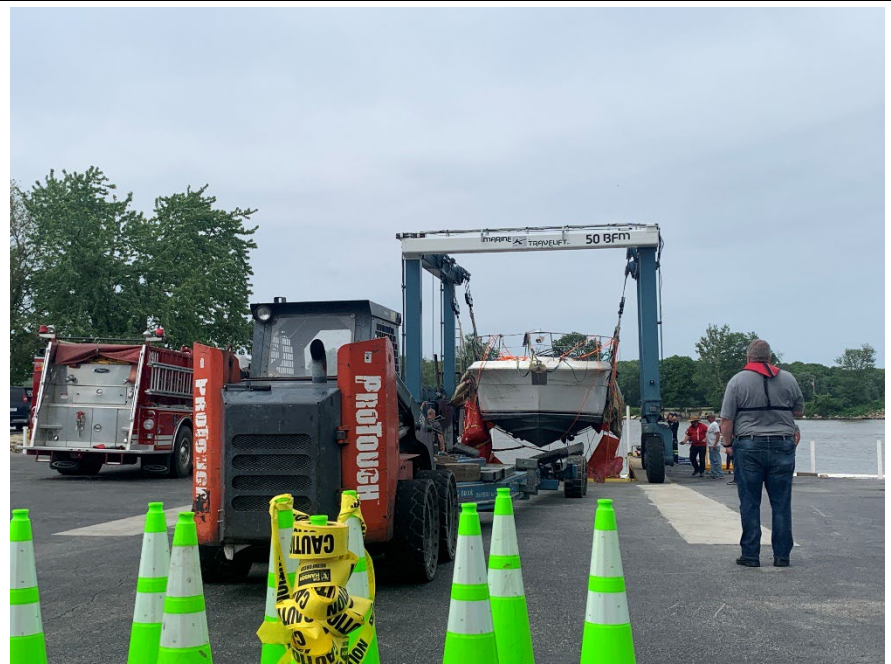
Photograph No. 8

Description: View of the retrieved vessel being placed on a trailer.

At 1513 hours, the intact vessel was successfully lifted from the bay. The vessel was then placed upon a trailer and transported to another location for investigation. The PRP used nets to collect and remove debris gathered against the booms for disposal.

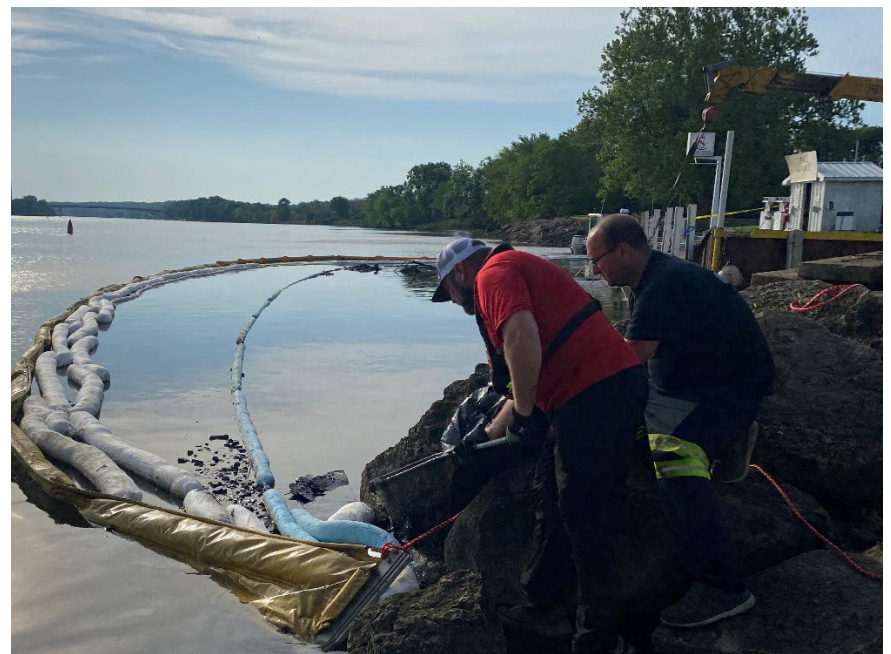
Photograph No. 4

Description: View of the PRP contractor, Tow Boat US, using nets to remove debris from the Illinois River.
